THE GREKUL HOUSE: A Land Use and Structural History

Occasional Paper
No. 14

Demjan Hohol'

March 1985

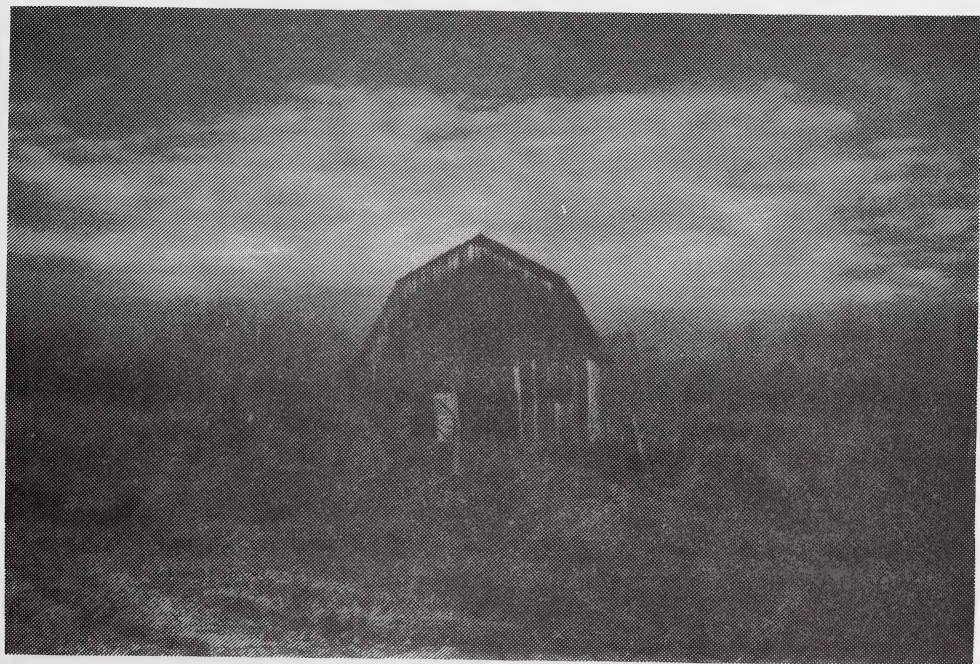
Fig. 14. The stáinia (large barn) built for Nykolai Grekul by Petro Hutsul-Rizun in 1915. Photographs by Demjan Hohol', October 26, 1983.

In 1915, at the time of Vasyl Grekul's wedding, a stainia (large barn) was being built by Petro Hutsul-Rizun,⁷⁷ east of and downhill from the large house. The stainia had a gambrel roof, which allowed for the storage of hay and straw in its spacious loft (see Fig. 14). A corral was built to the south and west of the structure. Six-inch thick "slupky" (posts) were set into the ground at approximately twelve foot intervals, and interconnected with three or more "vorynia" (rails) nailed horizontally across the posts. The "vorynia" were about four inches in diameter, and flattened on one side. The first rail was placed approximately two feet above the ground, and the rails above them were spaced about one and one-half feet apart. A large gate was located on the west side of the corral, directly in front (south) of the barn.⁷⁸

After Hryhorii's death in 1969, Axenia moved into Smoky Lake with her nephew, John Wolansky, who continued to farm the land. Although Axenia continued to keep a garden north of the large karnyk for a few years after her husband's death, the yard, like the large house, was allowed to deteriorate.¹³⁵ No buildings were intentionally destroyed, but as they no longer were being used, no effort was made to maintain them. The "karnyky" were the first buildings to collapse, soon followed by the west wall and ceiling of the khatyna. The modernistic kurnyk (chicken coop), and the beautiful "shpykliar" (granary) were still in good repair in the summer of 1983, but the stainia (large barn) was beginning to cave in (see Fig. 14).¹³⁶

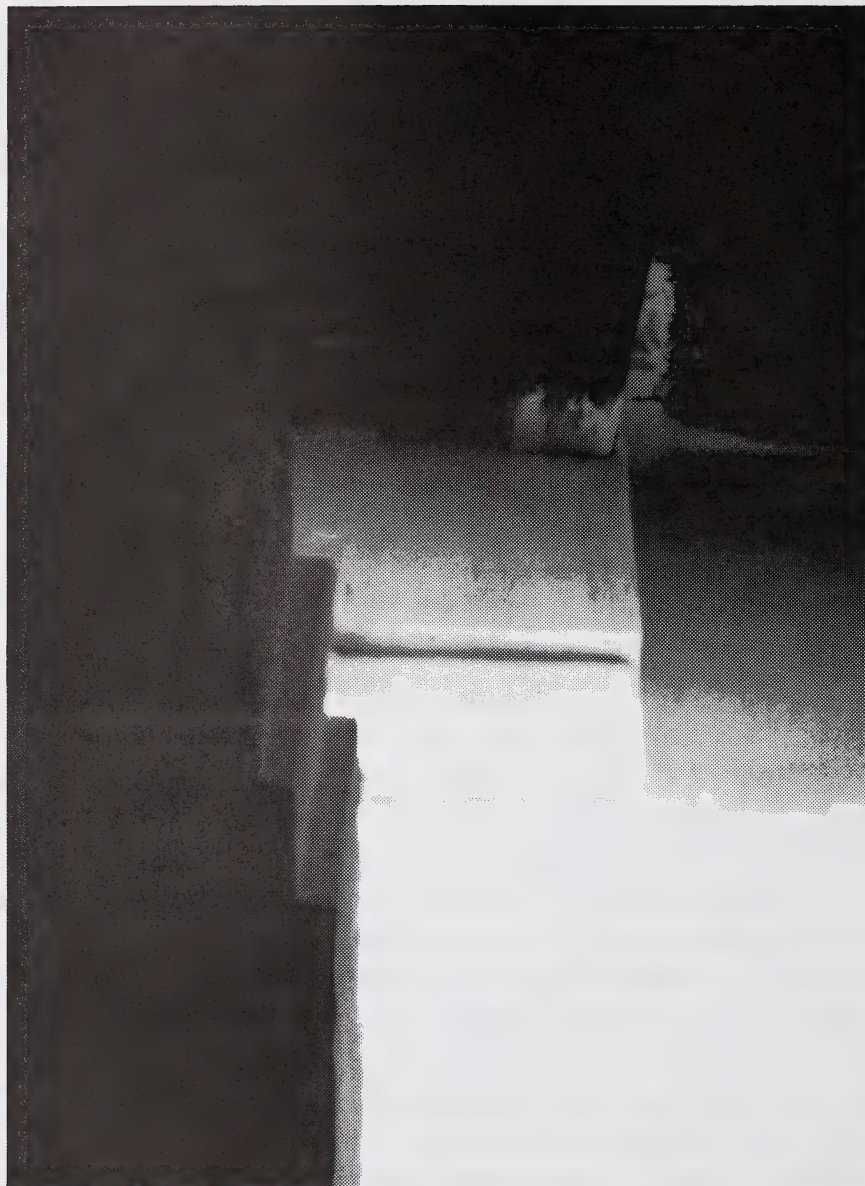
Fig. 23. The south-west vuhla (cornice bracket) of the Grekul House. Photograph by R. Bilash, 1978.
